EVRIock QB1-HT Field Trial

Ensign 112E – July 2013 EVRlock QB1-HT Field Trials

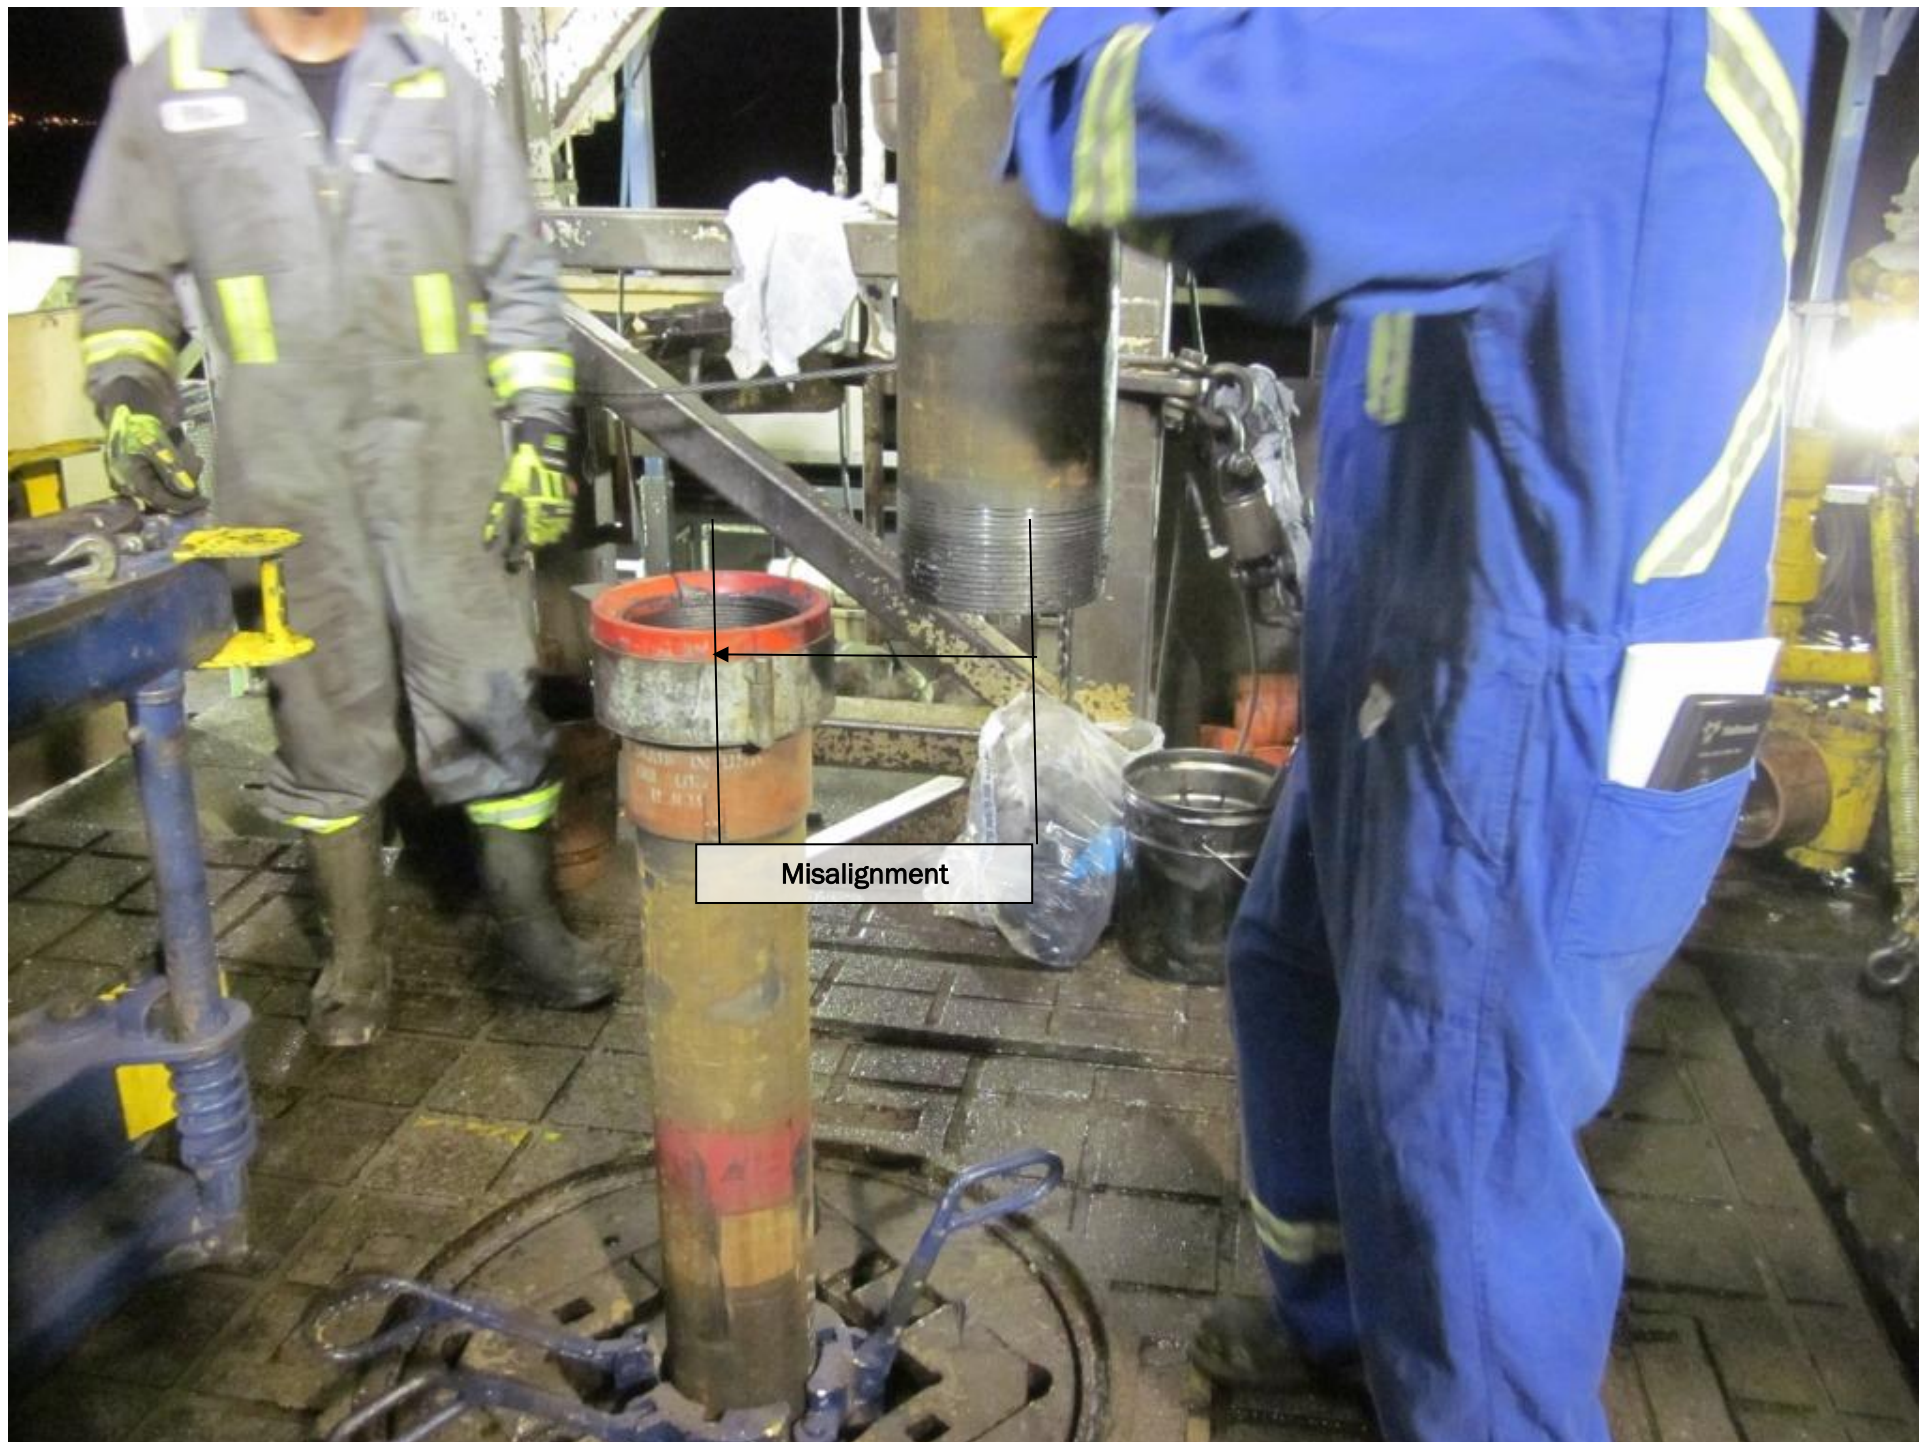
Misalignment

| Alignment Condition | Stab Process | Temperate Rise at Power Tight | Observations Upon Break Out |
|--|--|---|---|
| # 6 Two pipe diameters | Pushed into position (with guide and slow) | + 112°F | Moderate to severe galling (the galling was very evident on the WinCatt). The vertical misalignment was very noticeable |

- Alignment of the pipe prior to stabbing and make-up plays a very important role in determining the success rate of connection make-ups.
- Connections that are reasonably aligned combined with thread compound applied in an appropriate manner will provide good serviceability.

1. The need to “back spin” the connection prior to makeup is neither required or recommended.
2. Pipe alignment over the stump of should exhibit < 0.5 pipe diameters of lateral misalignment prior to being pushed into the stab position.
3. The use of a stabbing guide is recommended because more damage was noted when the pin was “face stabbed” on the coupling than when it was “kicked in.”
4. The connection exhibits good resistance to moderate changes in make-up torque; therefore, computer-based torque monitoring may not be required once data from the first three to four strings is reviewed and analyzed.
5. Green Seal Supreme thread compound has met all expectations for field serviceability on EVRlock QB1-HT connections and appears to provide good resistance to galling.

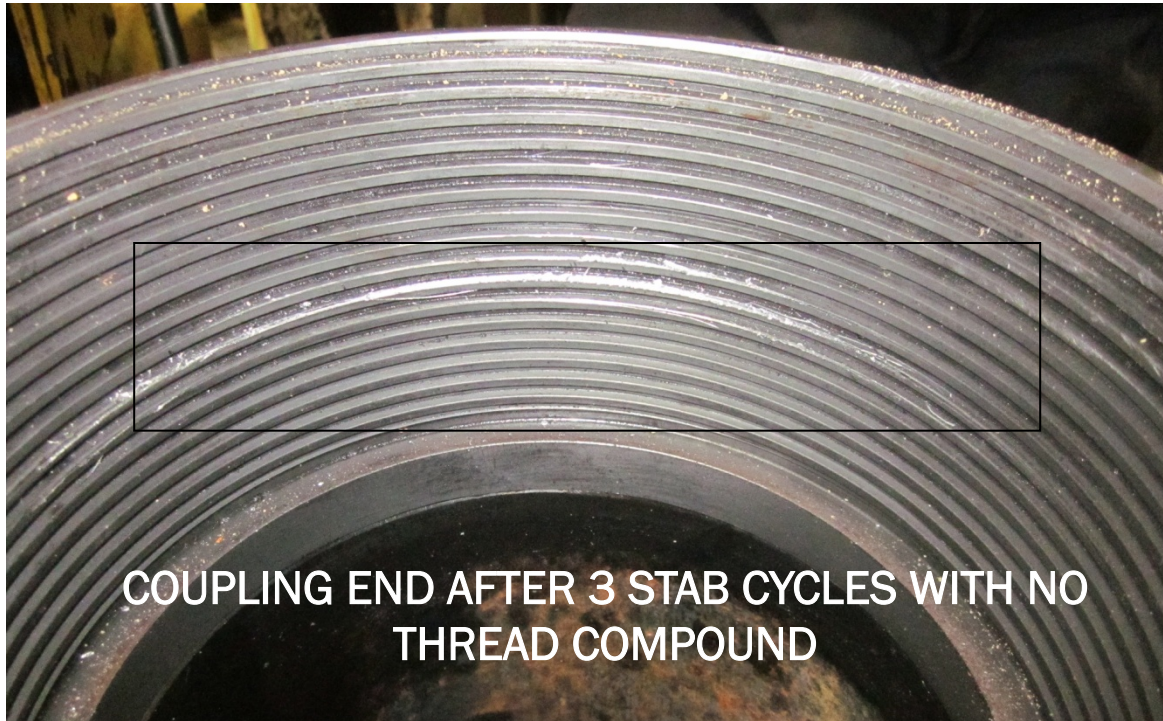
COUPLING END AFTER 3 STAB CYCLES WITH NO
THREAD COMPOUND

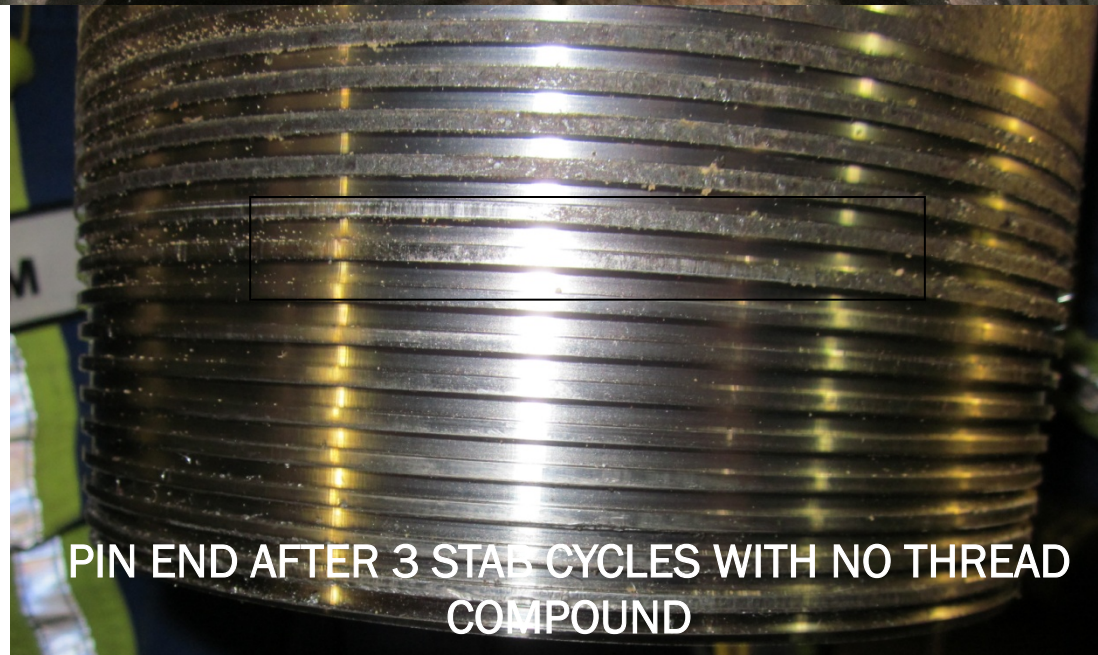
PIN END AFTER 3 STAB CYCLES WITH NO THREAD
COMPOUND

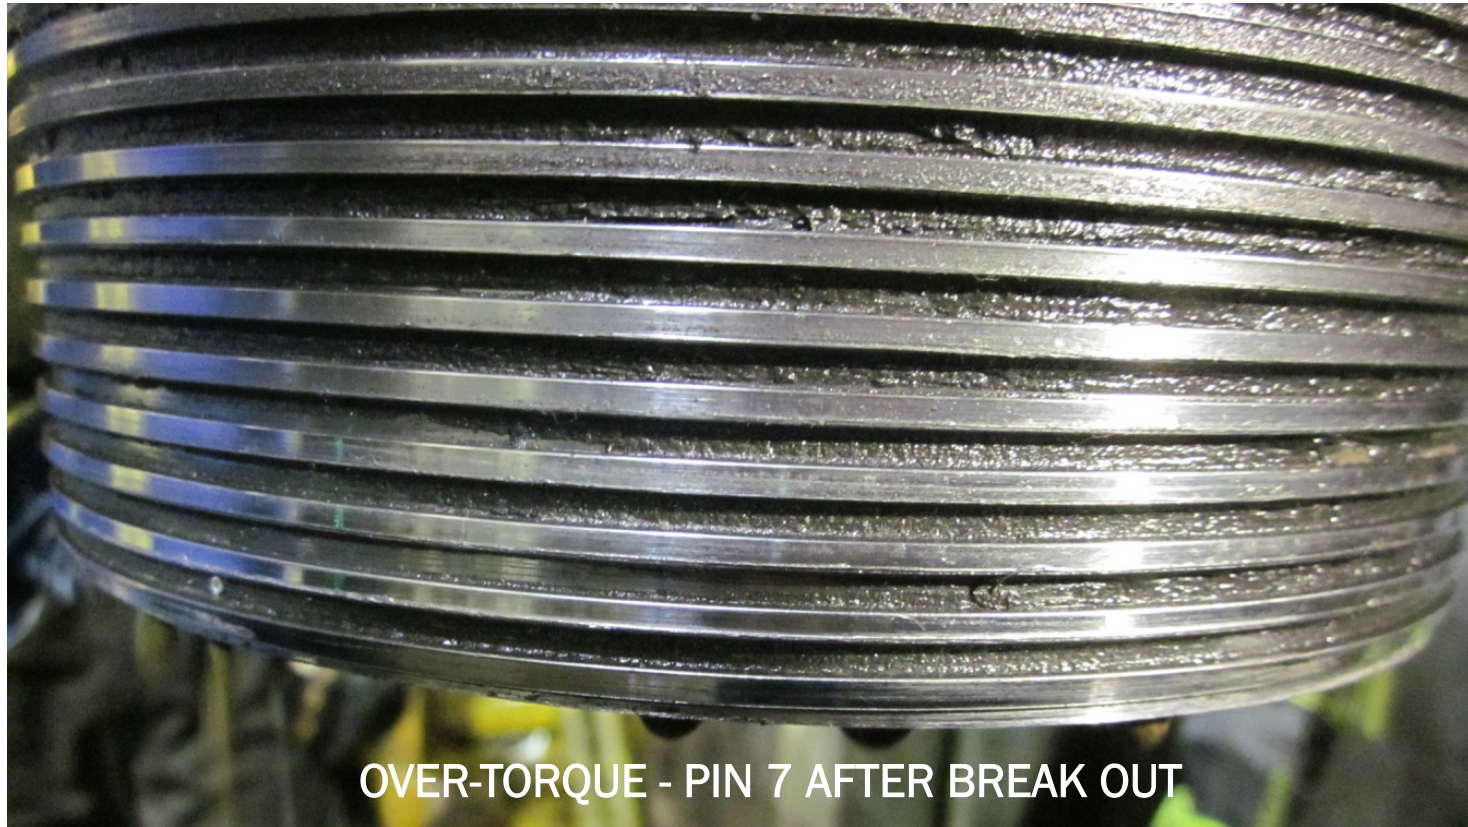
| | Pin End Condition | Coupling End Condition |
|---|--|---|
| # 1 | Feather edge on starting thread rolled in; some rolling of black crested threads | Scuffing of phosphate with very minor flank rolling |
| #2 | No change | Minor rolling of load flank |

OVER-TORQUE - PIN 7 AFTER BREAK OUT
